Safe Midline Diastema Closure in the Presence of Porcelain Veneered Central Incisors

Antonio Garrett ¹, Parmjit Singh ^{2*}

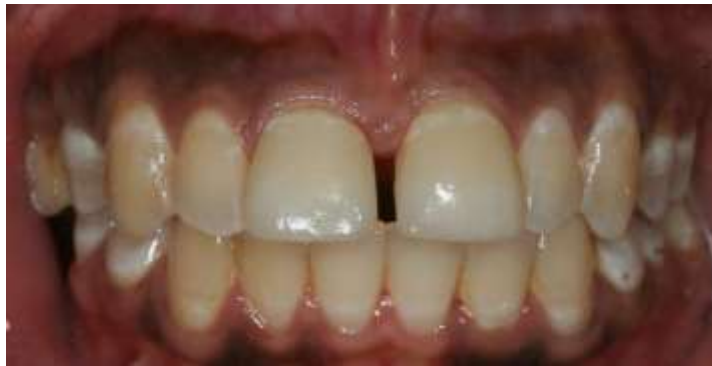
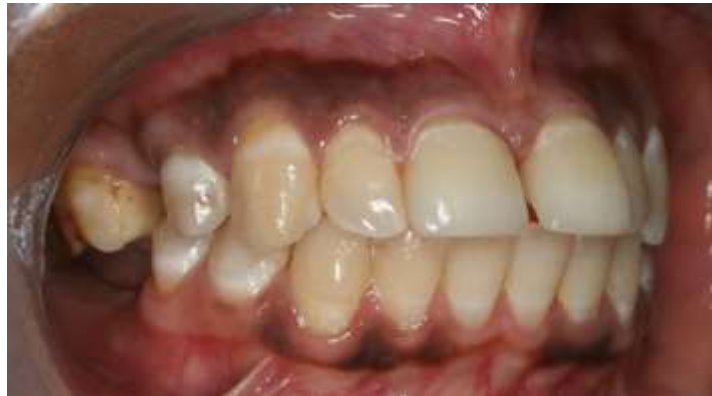
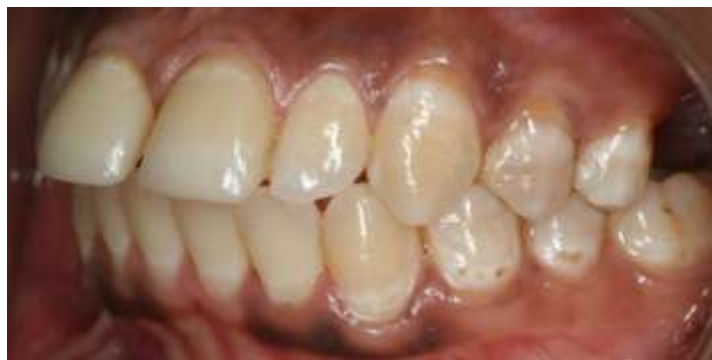
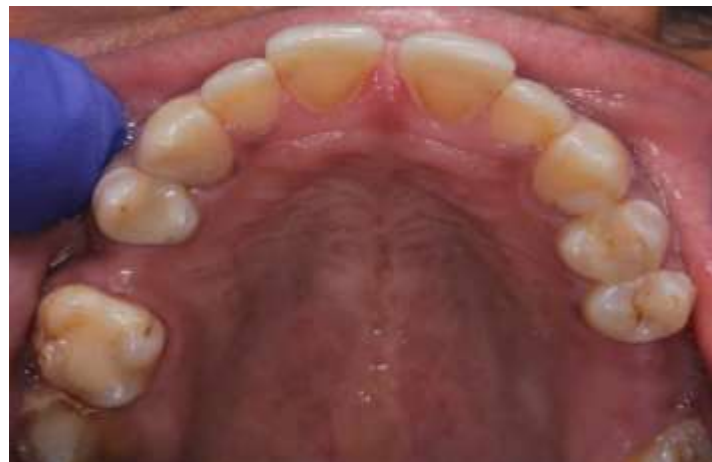
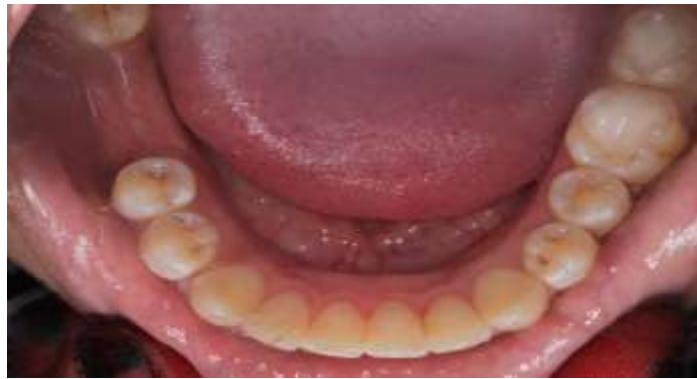
Figure 1. (a-e) A 29-year-old female with a maxillary midline diastema and porcelain veneers on the maxillary central incisors. The arches were well aligned, and the buccal segments had an acceptable occlusion.

A healthy 29-year-old female presented with the chief complaint of a maxillary midline diastema (Figure 1. a-e). The patient reported a history of having a diastema previously, but this had been filled using porcelain veneers on both maxillary central incisors some years ago. Recently, a diastema had reappeared, and the patient was now seeking an orthodontic resolution along with a commitment to indefinite retention. The periodontal condition was assessed and found to be satisfactory. The patient was happy with the colour, shape and size of the veneers and preferred for them not to be disturbed. The patient reported that the restorative treatment had cost her a considerable sum of money and therefore neither wanted the porcelain veneers replaced, nor damaged

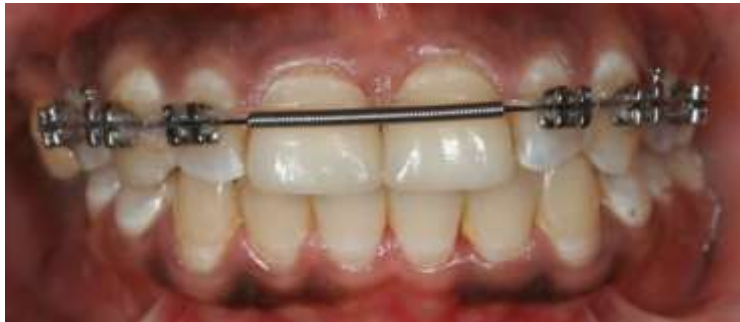
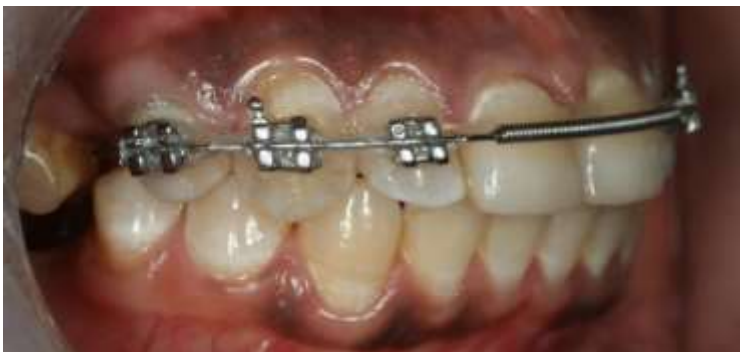
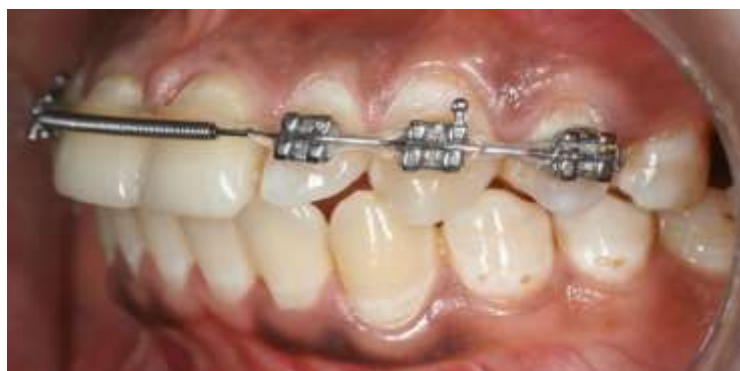
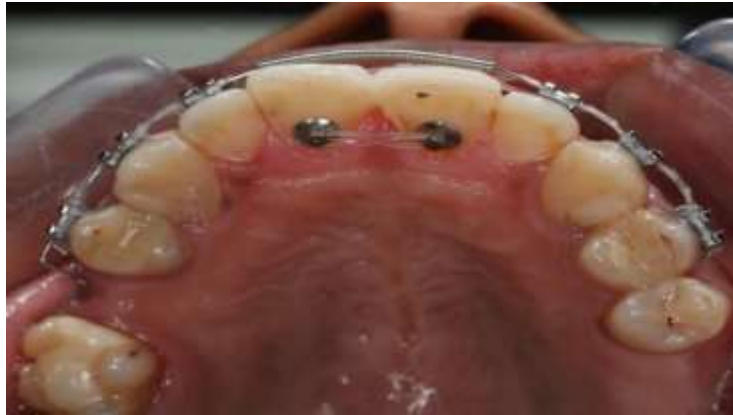
Figure 2. (a-d) Sectional labial fixed appliance bypassing the porcelain veneers on the maxillary central incisors. Palatal buttons were placed, close to the gingival margin, to minimise any rotation and tipping of the central incisors.

premolars using MBT pre-adjusted Edgewise brackets. The central incisors were bypassed to avoid bonding the porcelain veneers (Figure 2. a-c). After initial alignment with 0.014" and 0.018" nickel titanium wires, a 0.018" stainless steel working arch wire was placed. Elastomeric chain was used to close the diastema.

To reduce the introduction of mesiopalatal rotations of the maxillary central incisors, palatal buttons were placed on both the central incisors (Figure 2. d). Since the porcelain did not extend to the palatal surfaces of the incisors, bonding to enamel was possible. Elastomeric chain was placed across the buttons to counteract any rotation effect from the labial force. The buttons were placed close to the gingival margin so that when the elastomeric chain was placed, it would direct a force closer to the centre of resistance of these teeth. This would minimise mesial crown tipping of the maxillary central incisors and the amplification of any dark triangle.

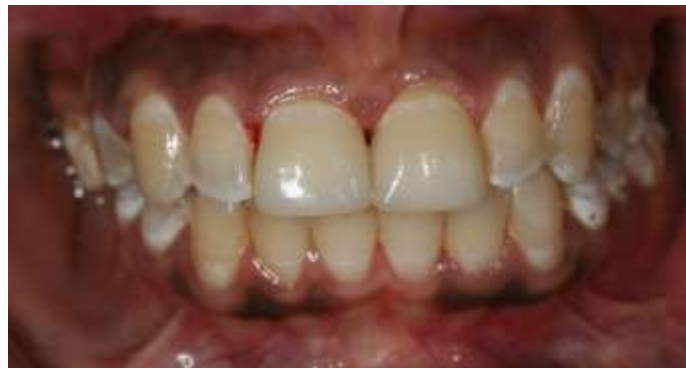
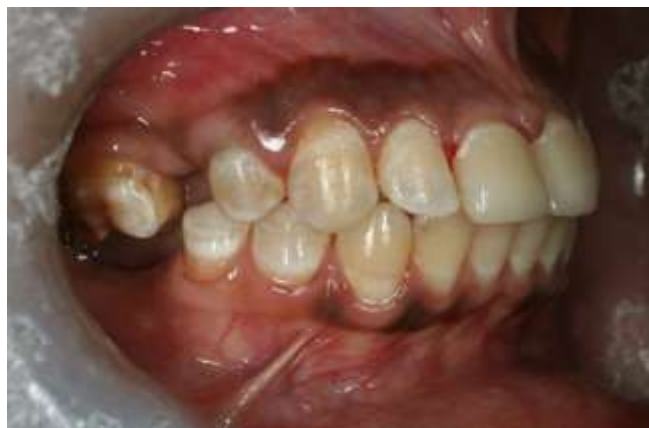
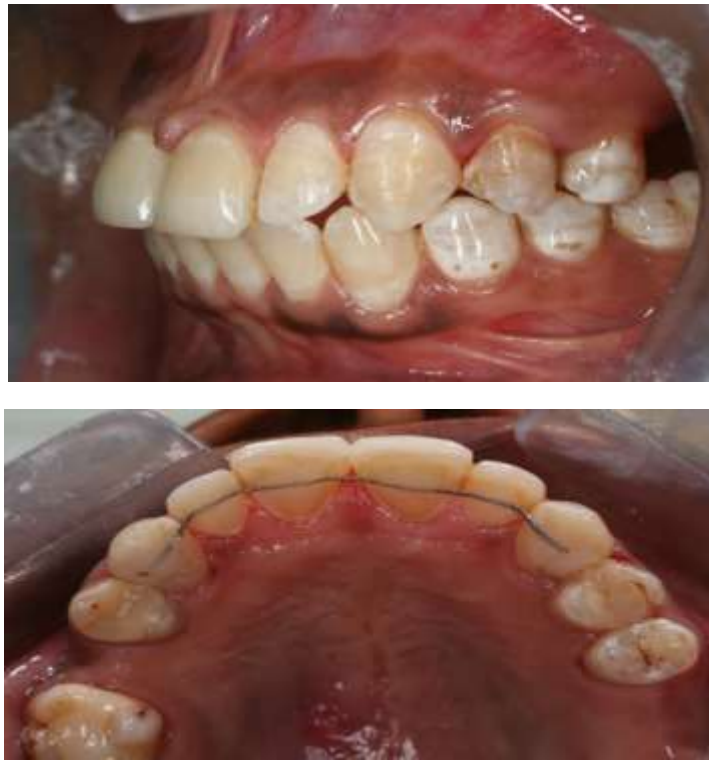
Figure 3. (a-d) The maxillary midline diastema has been closed in four months and a palatal fixed retainer on the anterior six teeth was placed. The buccal occlusion had remained stable.

Treatment was completed in just over four months and was concluded with the placement of a fixed retainer bonded to the maxillary six anterior teeth (Figure 3. a-d). This was supplemented with a vacuum formed retainer for nocturnal wear. The patient was very pleased with the outcome obtained and was grateful that the maxillary central incisor veneers were left intact.
