Wear and Deformation of Ceramic Implants in Total Hip Arthroplasty – Case Report

Case Presentation: A 72-year-old female, implanted 11 years prior, presented with mechanical pain and squeaking. Radiographs revealed femoral head eccentricity. A single-component revision improved the patient's symptoms. Implant analysis demonstrated abnormal wear and deformation of both the femoral head and the acetabular liner, without fracture.

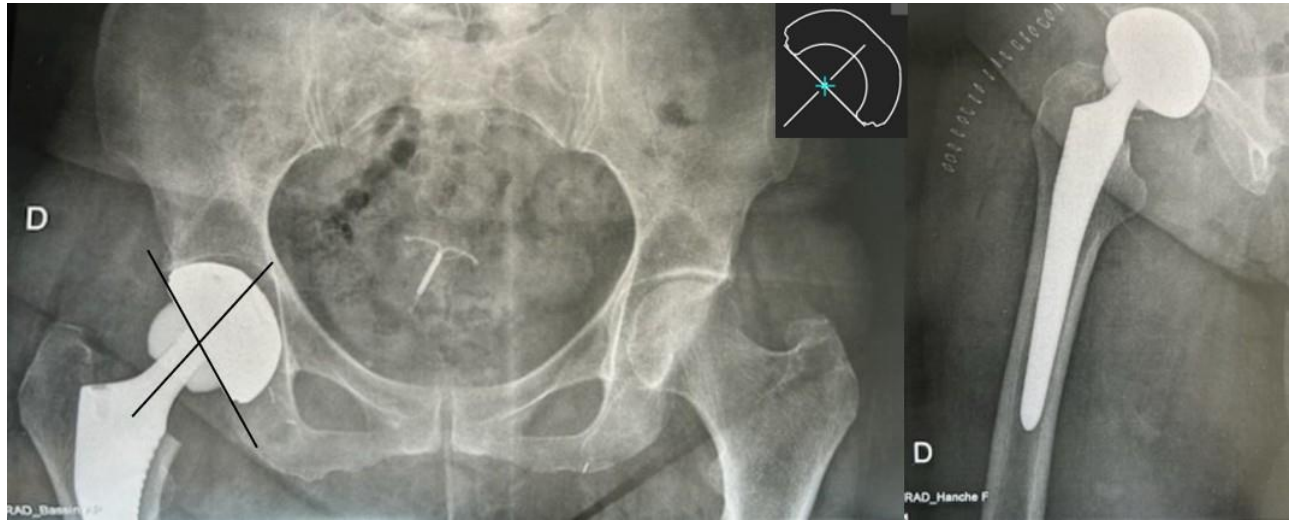
The immediate postoperative course was marked by squeaking. Postoperative radiographs showed a centered femoral head (Figure 1).

Figure 1: Postoperative anteroposterior pelvic and lateral right hip radiographs, 2013

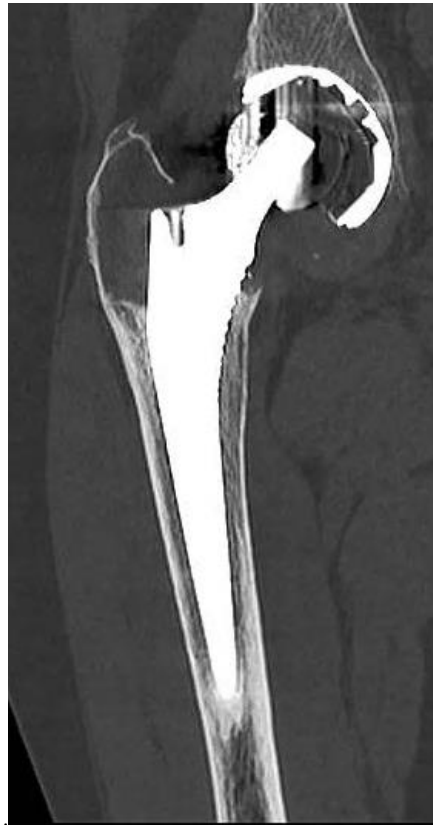
of the femoral head compared to the 2013 postoperative images (Figure 2). Wear measurements were obtained by adapting the method of Charnley et al. [4] used for polyethylene bearings, as no validated score exists for ceramic wear measurement on radiographs. CT confirmed cranial migration of the femoral head without clear fracture of the ceramic liner or head, and revealed femoral and acetabular periprosthetic granuloma (Figure 3).

Figure 3: Coronal CT scan of the right hip, 2024.

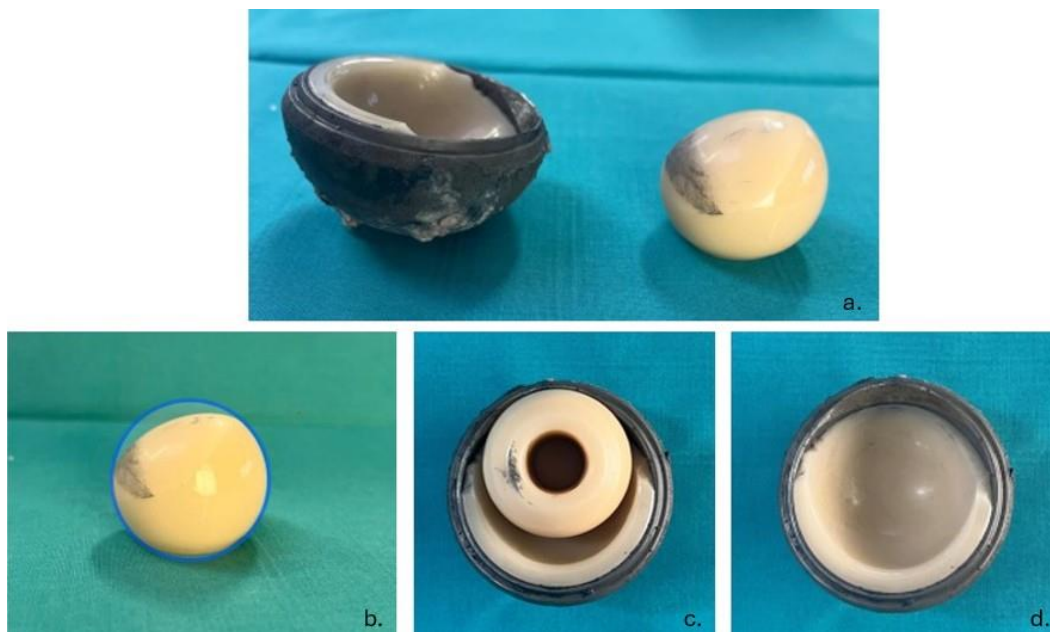
Revision surgery took place 11 years after the index procedure under general anesthesia, in left lateral decubitus. The initial posterolateral approach was reused. Intraoperatively, a grayish tissue adherent to the capsule was noted, but no granuloma. A millimetric ceramic fragment was found at the expense of the acetabular liner. Both the ceramic femoral

head and acetabular liner were deformed and asymmetric (Figure 4). The metal-back shell was removed without significant bone loss. After removal of the femoral head, the femoral stem showed no signs of wear or loosening and was left in place. A 61 mm diameter HYPE acetabular cup (SERF®) with a HYPE ceramic liner (SERF®) for 36 mm head was implanted after failure to obtain satisfactory stability with an Anexys cup (MATHYS®). A Biolox Option revision ceramic femoral head 36/+5 mm (SERF®) was implanted on the original femoral stem.

Figure 4. Retrieved worn implants (a)* Acetabular components and ceramic femoral head ; (b)* Wear and loss of sphericity of the ceramic femoral head ; (c)* Ceramic femoral head in situ ; (d)* Wear of the ceramic liner with exposure of the metal-back

The MATHYS® (Mathys Ltd Bettlach) materiovigilance report identified organic deposits between the ceramic liner and metal cup. Loss of implant geometry was also noted, resulting in superior edge loading. Multiple liner fractures were observed, some recent with sharp edges and others older with rounded edges. The ceramic femoral head displayed stripe wear, loss of sphericity, and a wear volume estimated at 13.34 mm³.

Several hypotheses may explain the deformation of the ceramic femoral head in this case. The first is direct wear, which seems unlikely, as in vitro wear with this generation of ceramic is <0.1 mm/year [7,14]. The time to implant failure is too short to explain this level of wear. The analysis revealed an annual wear rate of about 1.21 mm/year—over 10 times the usual rate [7,14].

The most probable explanation is third-body wear caused by liner rim fracture during impaction, supported by the materiovigilance findings.
